NASA TM X-1119

INVESTIGATION OF ATLAS SOLID
FUEL RETARDING ROCKET DURING
ATLAS-CENTAUR SEPARATION TESTS

*Lewis Research Center
Cleveland, Ohio*

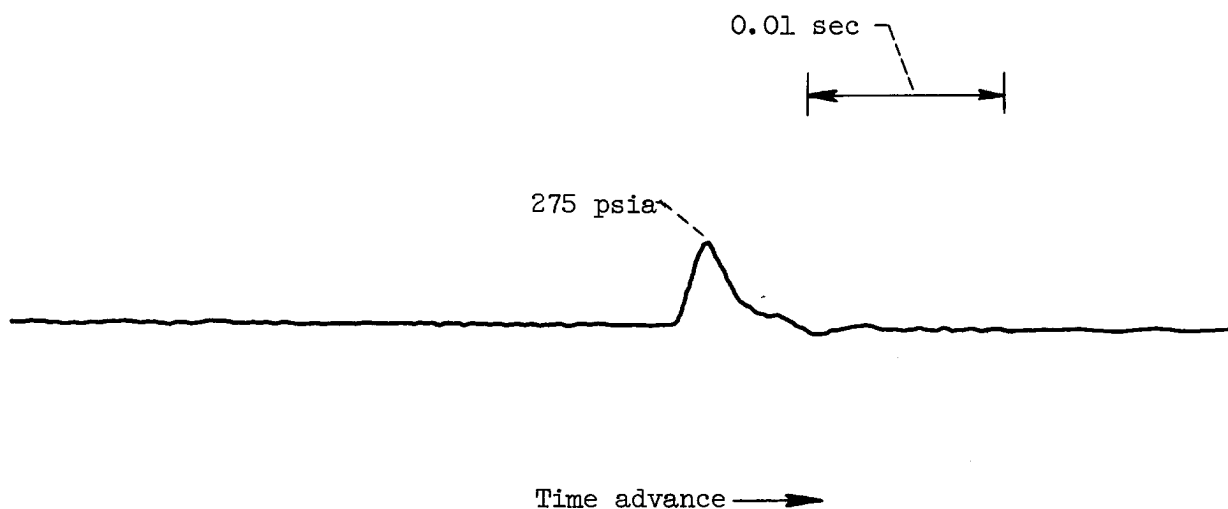
Of the 67 units fired, 6 misfires were encountered when Ordnance Associates igniters were used. Examination of the misfired units revealed that the grain was intact, the nozzle diaphragm (which was in accordance with the flight configuration) when used was ruptured and partly extruded into the nozzle, and the igniter was fired with no part of its "propellant" to be found in the rocket (figs. 4 and 5). The characteristic pressure record from a misfired motor is an abrupt pressure rise to approximately 250 to 450 pounds per square inch, after which a rapid decay ensues (fig. 6).

Figure 6. - Typical pressure trace of misfired rocket.

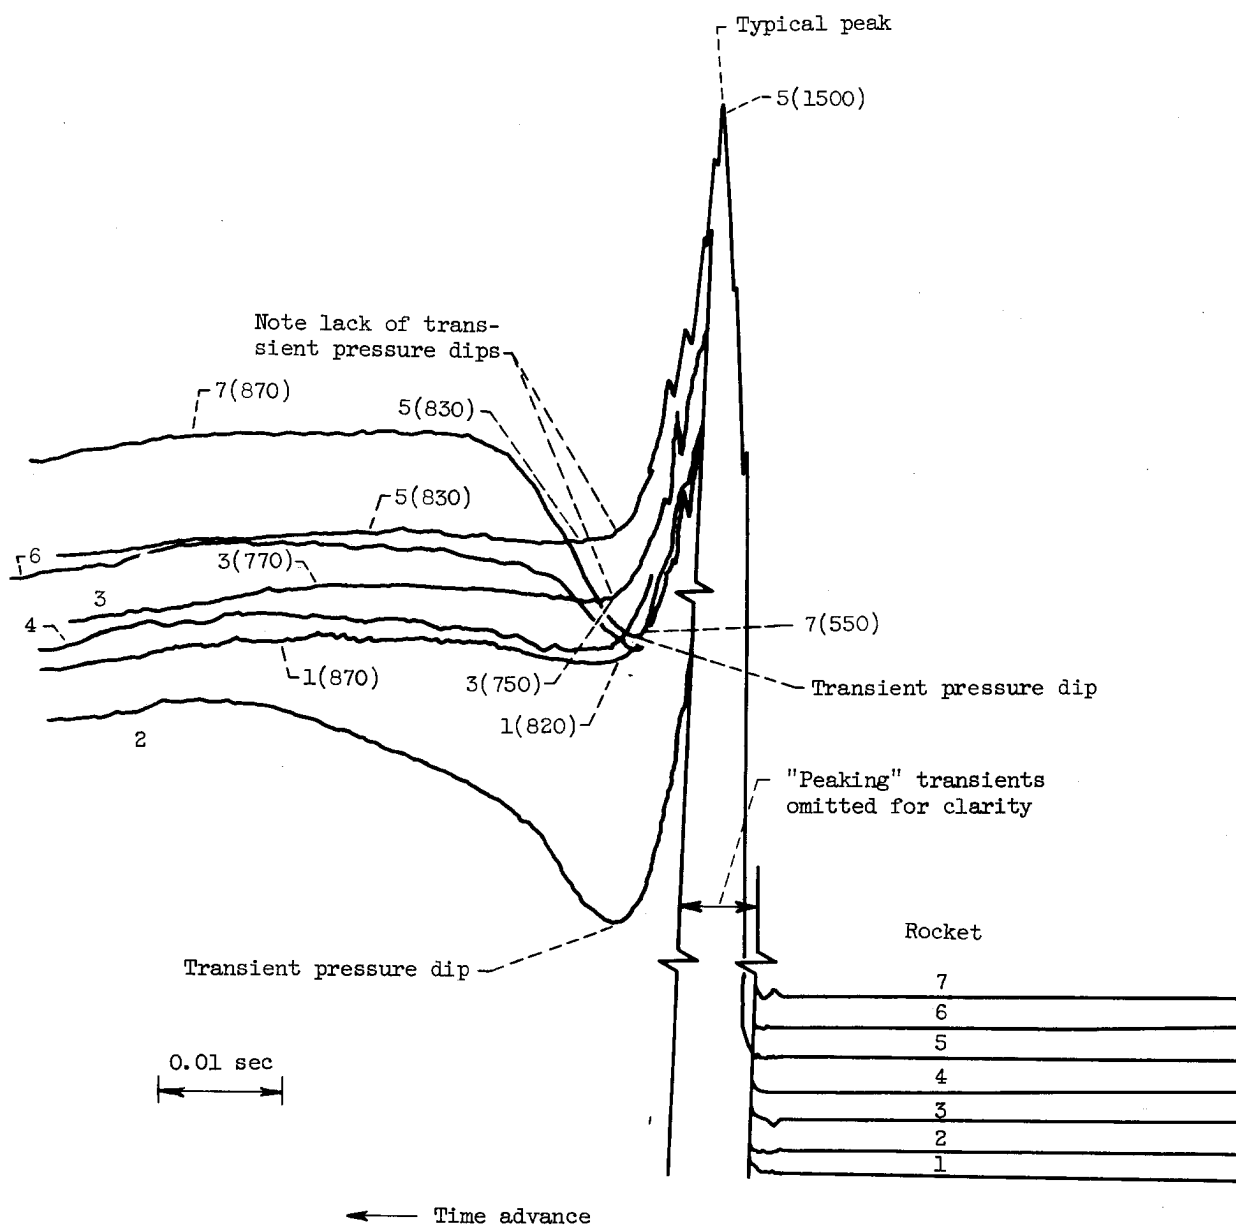
Pressure traces obtained in the test firings were scrutinized in an effort to discover any apparent inadequacies in the ignition cycle which could be related to the igniter changes. In several instances an abnormally low chamber pressure occurred between the ignition peak of approximately 1500 to 2000 pounds per square inch and the steady-state burning pressure (fig. 8(a)). In order to understand this occurrence, eight rockets having lot 2-1 igniters were fired with a 1/8-inch hole drilled through the nozzle closures so that the chambers were at a near vacuum condition prior to firing. The pressure traces from this test firing, which are shown in figure 8(b), revealed that each engine experienced a pressure falloff similar to that mentioned earlier although not quite as severe. The generation of the falloff, or saddle, in each instance is felt to demonstrate a susceptibility of the igniter to an initial low-pressure condition in the combustion chamber and to give an indication of inadequate performance margin. The pressure falloff probably results from the propellant grain not being sufficiently ignited at the time of igniter burnout and could probably be eliminated with the use of a longer burning igniter. While these tests did serve to uncover a marginal performance characteristic, they did not explain why lot 3-2 igniters produced misfires and lot 2-1 igniters did not under normal conditions.

(a) Random failures.

Figure 8. - Pressure records of incipient rocket failures. Numbers in parentheses are peak pressures and pressure dips in psia.

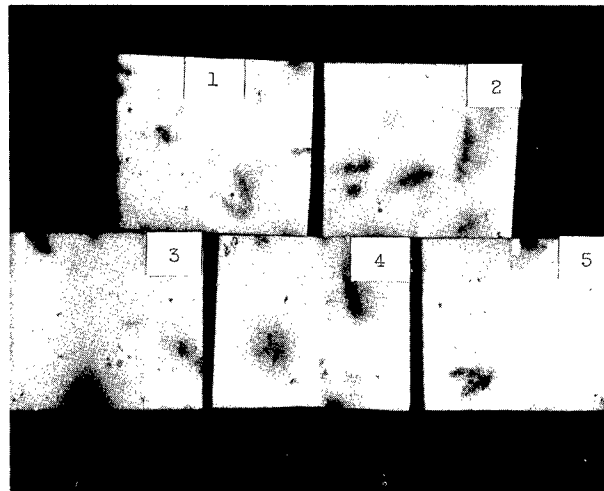
Some tests were conducted by Beckman and Whitley Laboratories to determine what had caused the 3-2 igniters to lose all their margin of performance. Both the lot 3-2 igniters and the lot 2-1 igniters, which had no record of misfires, were fired into Styrofoam blocks to make a record of flame-impingement patterns. Their findings, noted in references 1 and 2, reveal that the lot 2-1 igniters consistently displayed a widely dispersed flame pattern, while the lot 3-2 igniters were inconsistent. The 3-2 units occasionally fired an extremely narrow and concentrated flame front (fig. 10). This characteristic leads to the theory that the lot 3-2 igniters when their discharge pattern is concentrated do not impinge on the grain surface sufficiently and, therefore, may not impart enough heat into the grain to cause ignition. This inconsistency in performance may be inferred to result from the previously described changes in the igniter's geometry. The combination of an initial low performance margin and an inconsistent flame discharge pattern is apparently sufficient to cause occasional ignition failures. Supporting this conclusion are data obtained at Lewis from the firing of two igniters manufactured by Librascope (fig. 11) whose constituents were described earlier. The first igniter firing at sea-level ambient pressure was made into a Styrofoam block, and a narrow impingement pattern was observed (fig. 12). The second firing, at a 98 000-foot-altitude ambient pressure, involved the installation of a Librascope igniter in a Rocket Power, Inc., rocket from which the nozzle closure had been removed. The igniter failed to ignite the rocket propellant, as would be anticipated from the flame pattern.

(a) Lot 2-1 igniters. Note widely dispersed patterns.

Figure 10. - Flame impingement patterns.

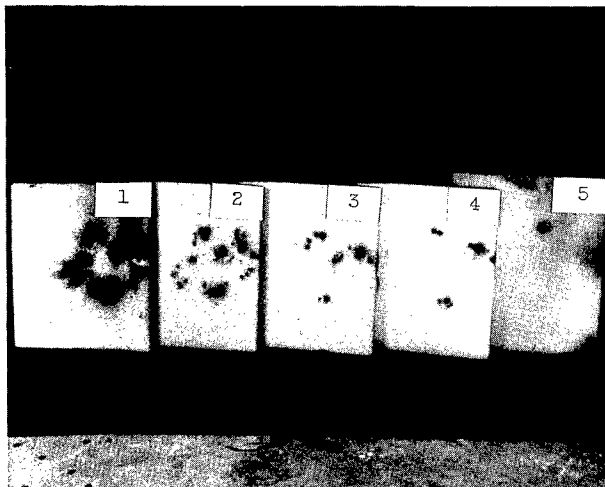
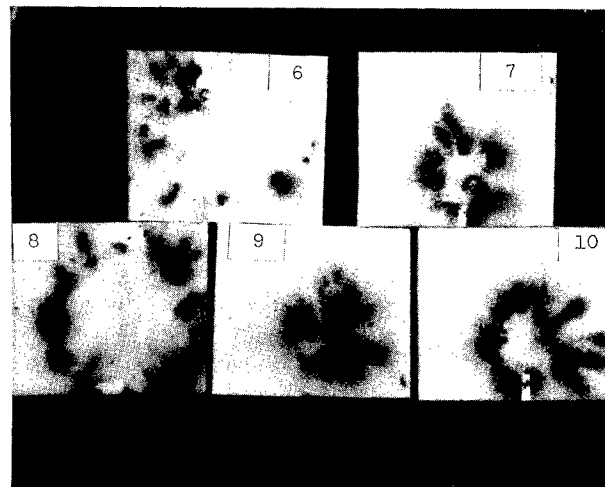
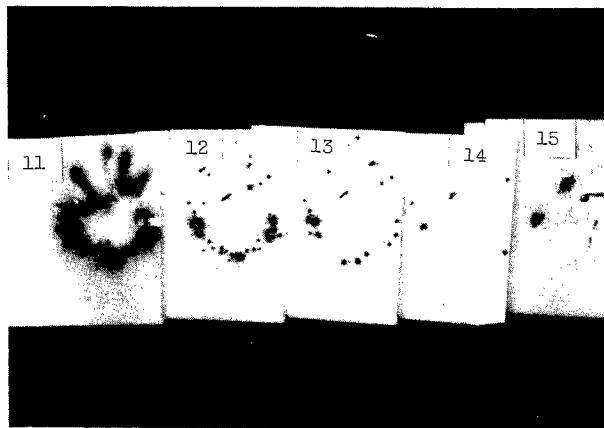
(b) Lot 3-2 igniters. Note narrowly dispersed patterns in 1, 7, 9, and 11 and widely dispersed patterns in 4, 5, 6, 8, and 14.

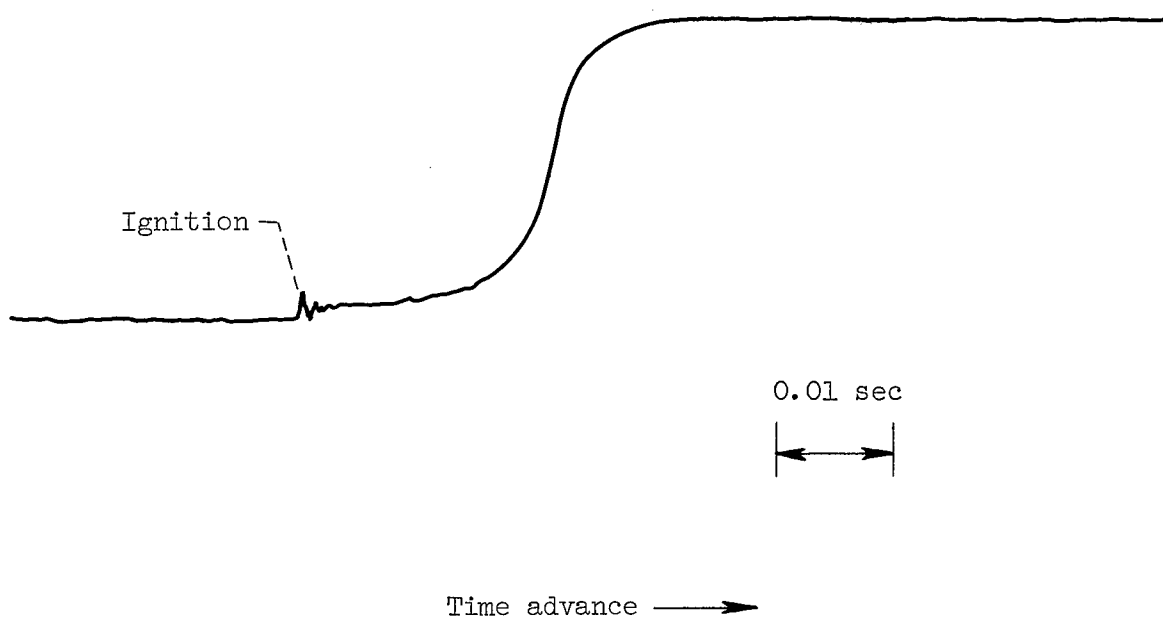
In order to further substantiate the theories concerning flame direction and igniter burning time outlined, a test was made at a pressure altitude of 98 000 feet with a Thiokol Chemical Corp. igniter (fig. 13), installed in Rocket Power, Inc., rocket having no nozzle closure. This igniter burns for a longer period of time (0.25 sec compared with 0.004 sec for the Ordnance Associates igniter) and directs the flame pattern at the rocket grain. The longer burning time is effected primarily by an increase in the igniter's constituent mass. The increase in the mass, with its resultant increase in heat content and burn time, coupled with the directed flame pattern tended to ensure that the rocket grain would receive sufficient heat to ignite. Successful ignition of the rocket propellant occurred (fig. 14).

Figure 14. - Internal pressure record of Rocket Power, Inc., rocket ignited by Thiokol Chemical Corp. Pyrogen igniter.

The specific causes for the marginal performance appear to be (1) an inadequate igniter burning time aggravated by (2) inconsistent igniter discharge patterns, which occasionally did not impinge on the rocket propellant grain. Therefore, it is desirable to substitute an igniter which (1) burns till the rocket grain is sufficiently ignited, and (2) directs its flame pattern positively towards the grain surface. *— end*
